REPORT NO. CASD/LVP 78-078  
CONTRACT NAS 3-20644

## ATLAS 5013 TANK CORROSION TEST

# ATLAS 5013 TANK CORROSION TEST

December 1978

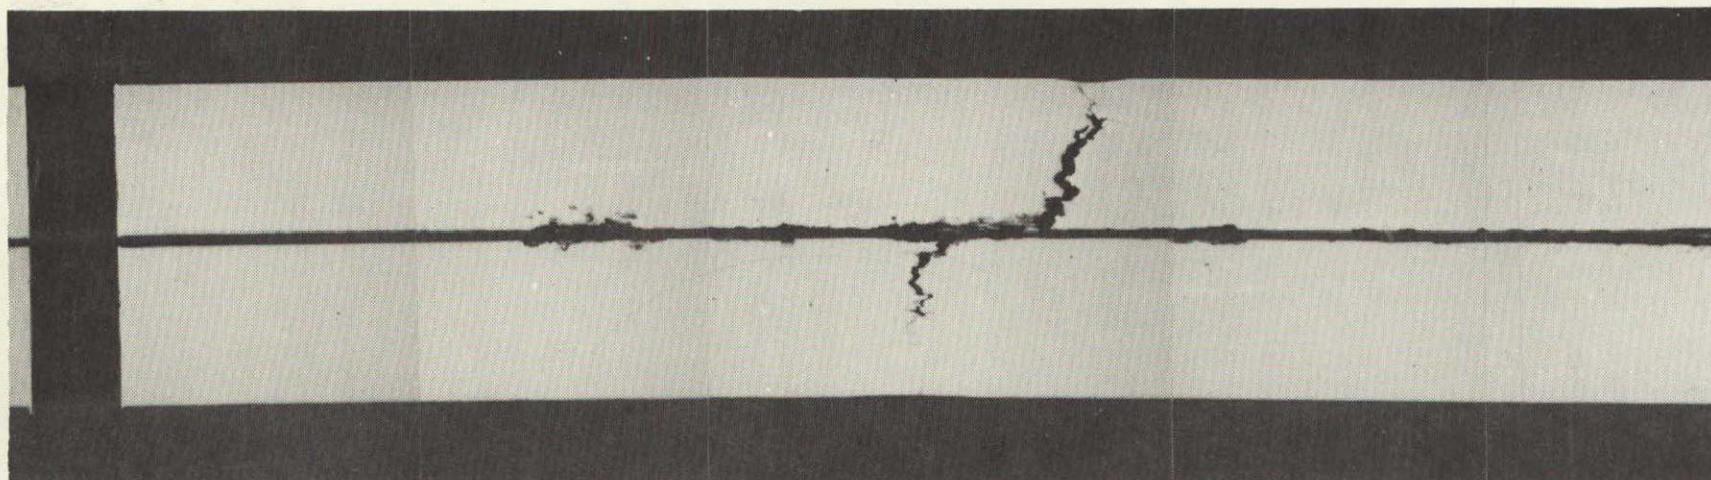
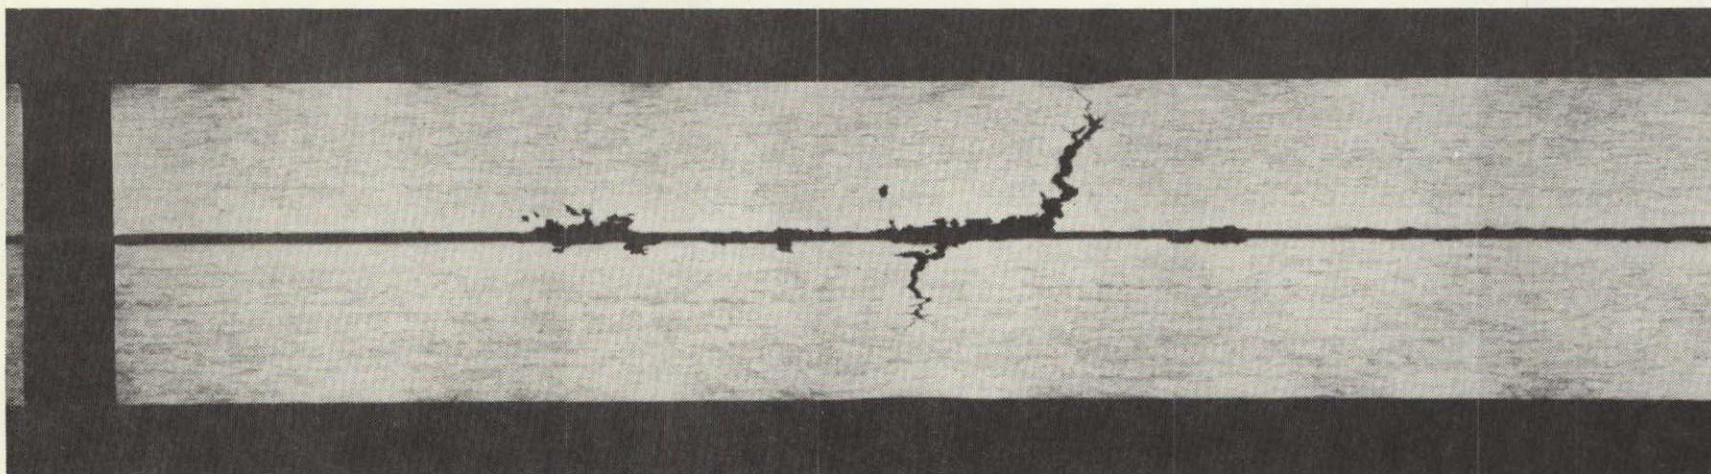
Figure 2-34. Appearance of Section A-A, described in Figures 2-31, 2-32, and 2-33, Showing Internal Cracking Beneath the Localized Surface Yielding Indications

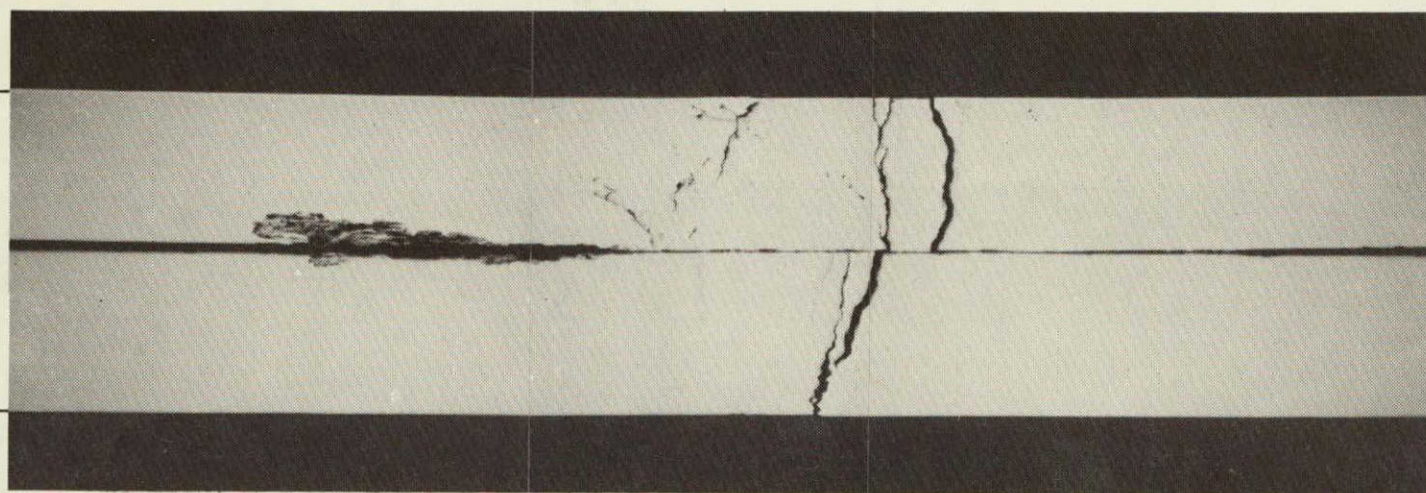
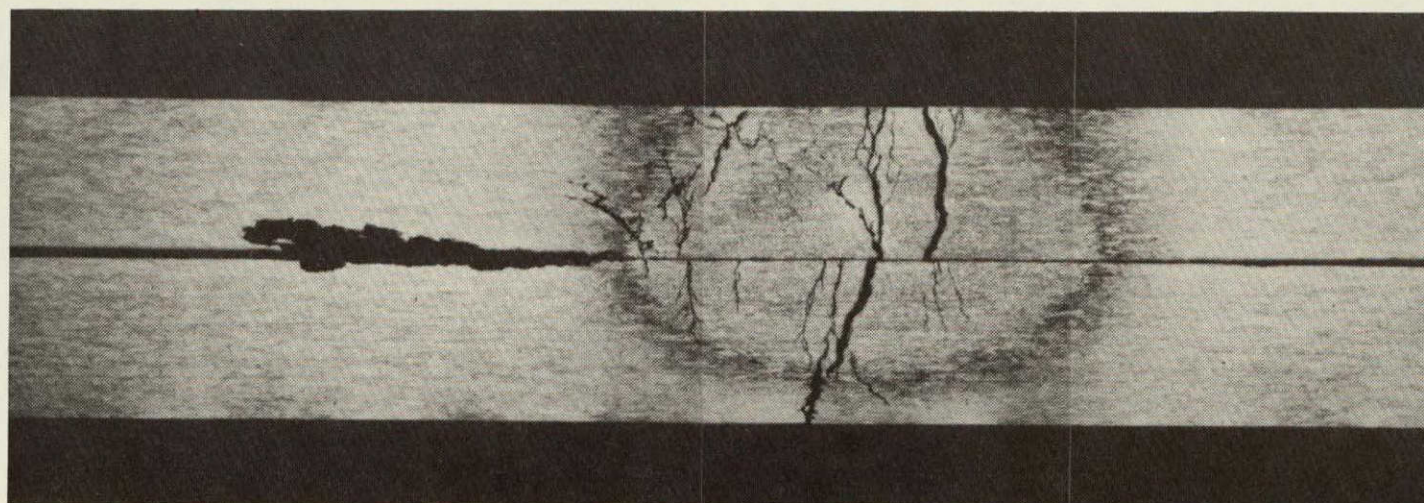
Figure 2-35. Appearance of Section B-B, Described in Figures 2-32 and 2-33, Showing Complex Stress Corrosion Cracking and a Continuous Leak Path from the Inside Surface to the Outside Surface

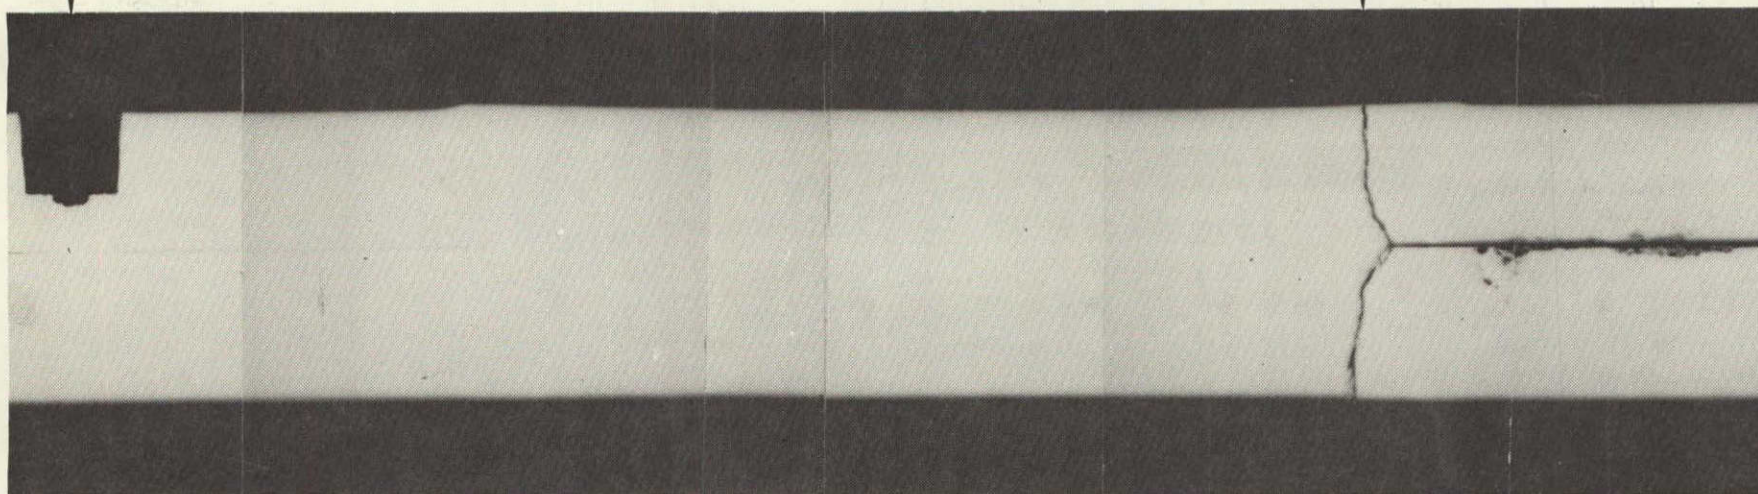
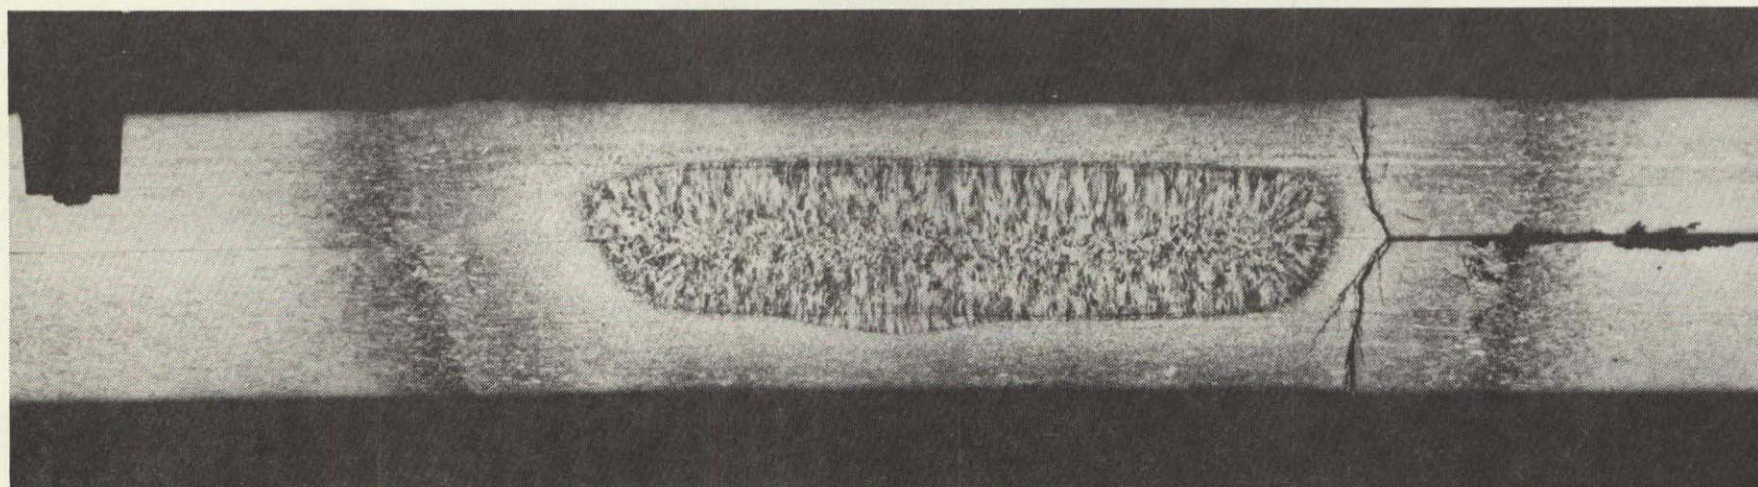
LEAKING CRACK

Figure 2-36. Appearance of a Section C-C Through a Visually Leaking Horizontal Defect Indication (Item 9) Shown in Figure 2-24

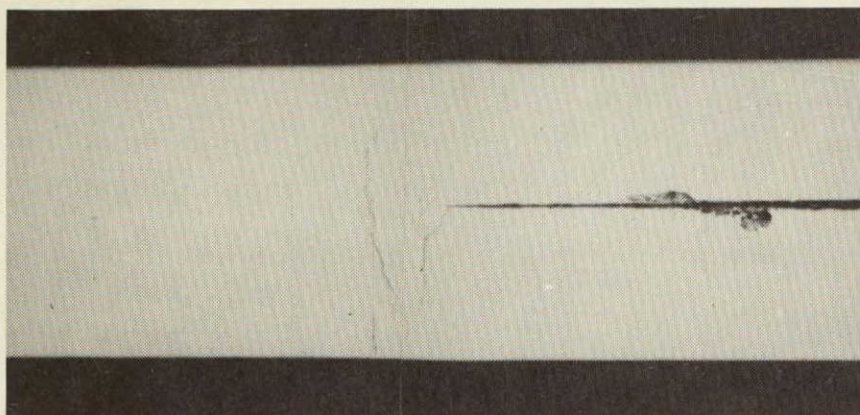
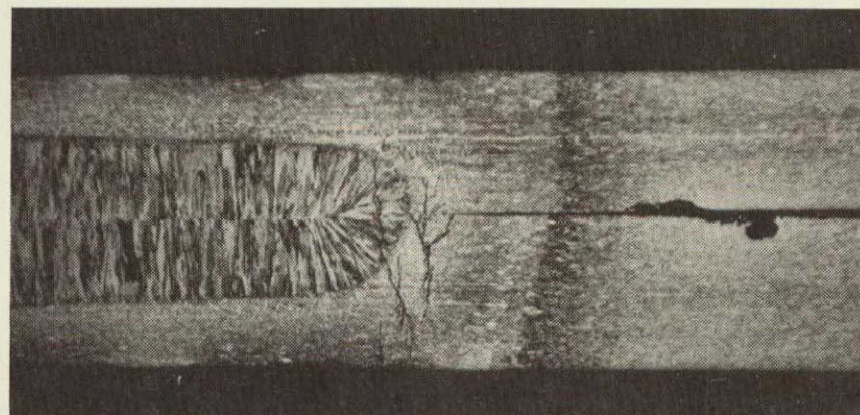
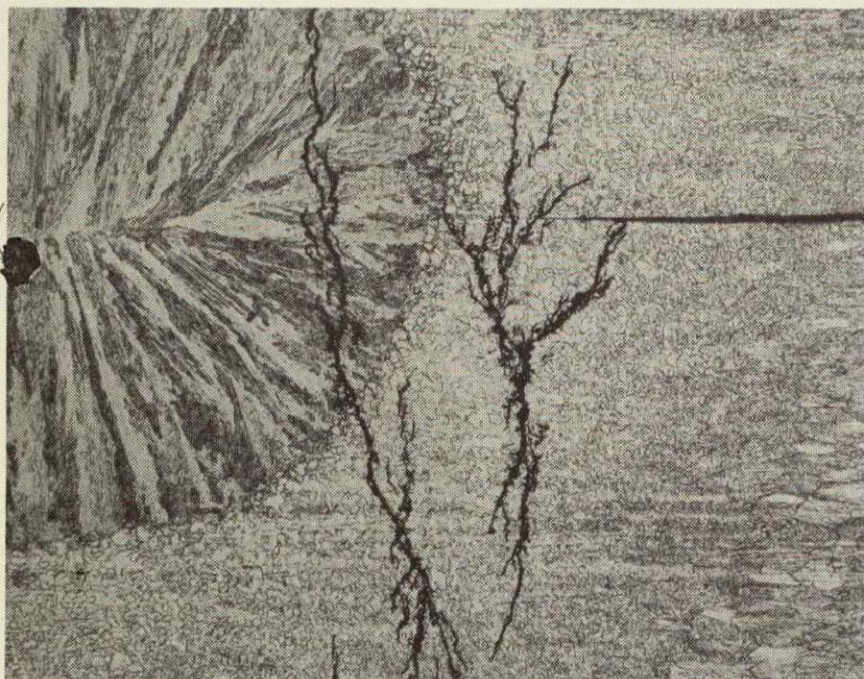
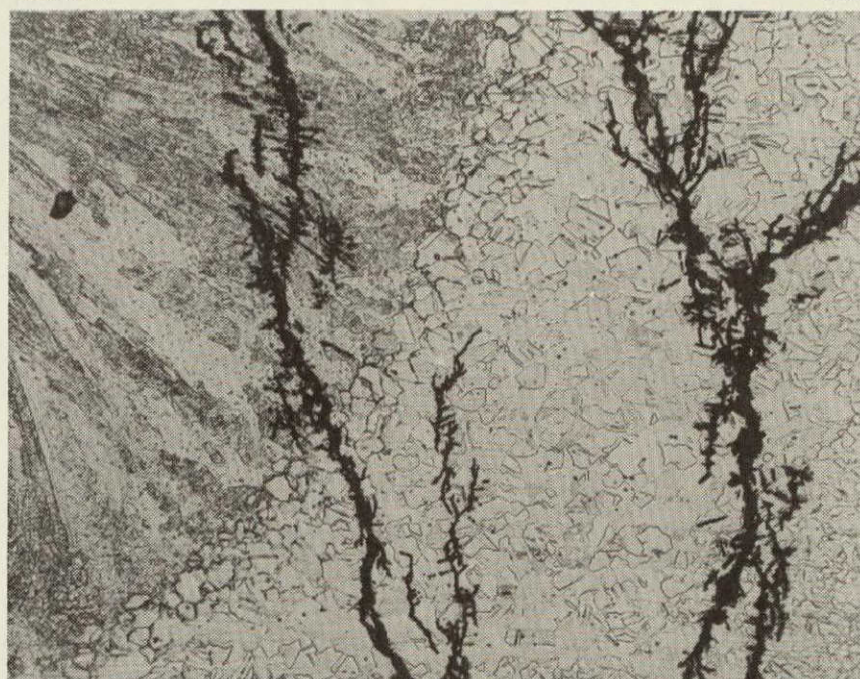
Figure 2-37. Section Level D-D, 0.125 Inch from Level C-C, Showing Stress Corrosion Cracks in Both the Soft Cast and Recrystallized Microstructures

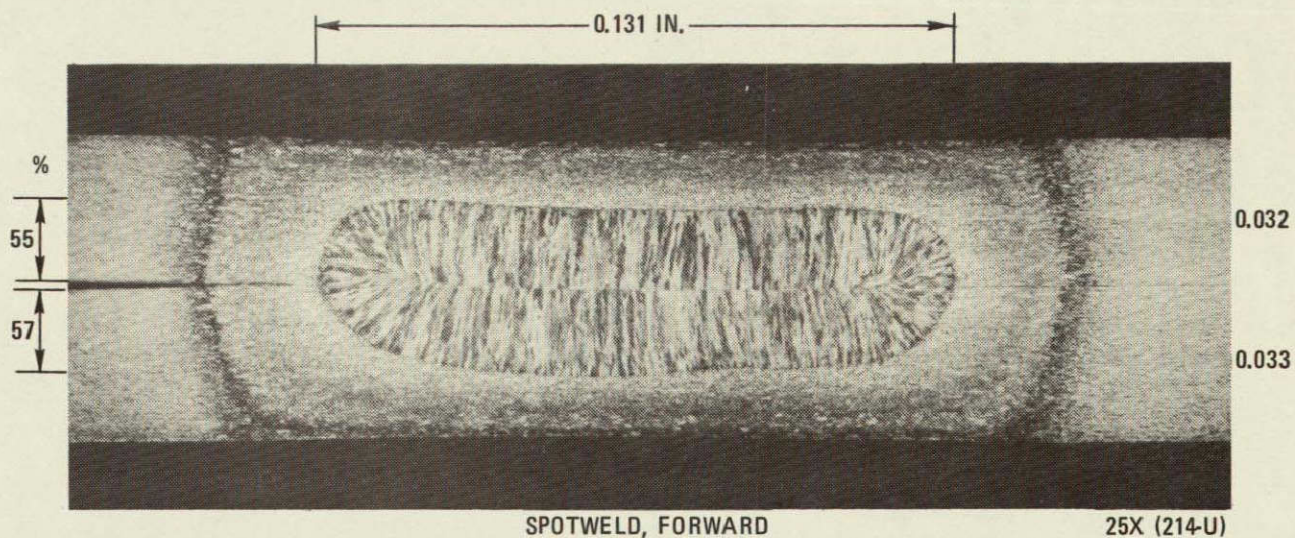
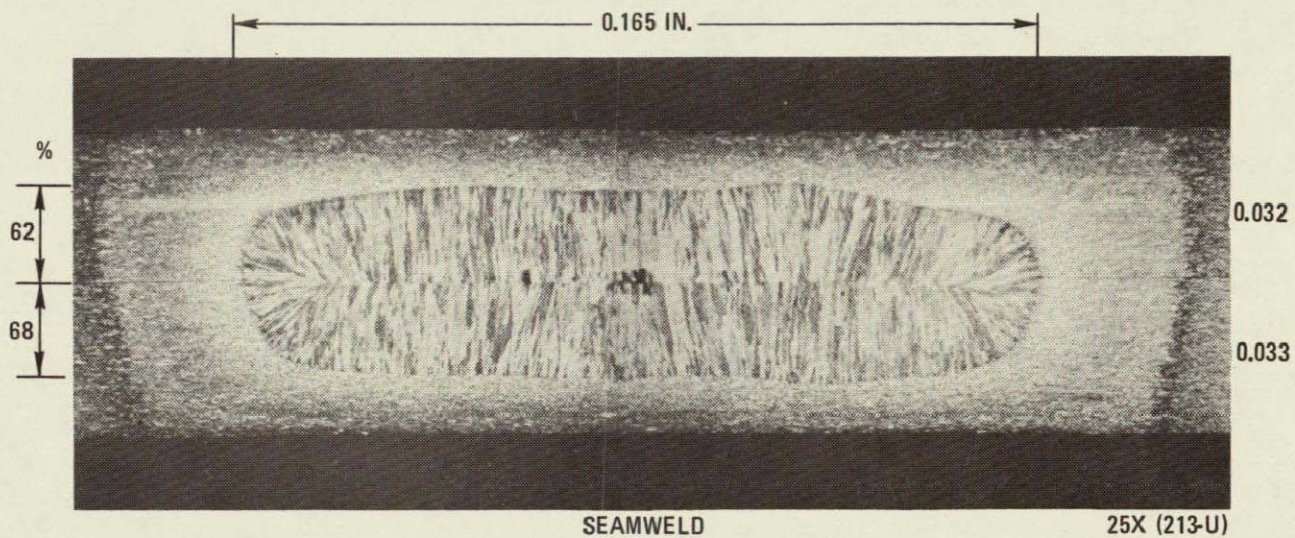
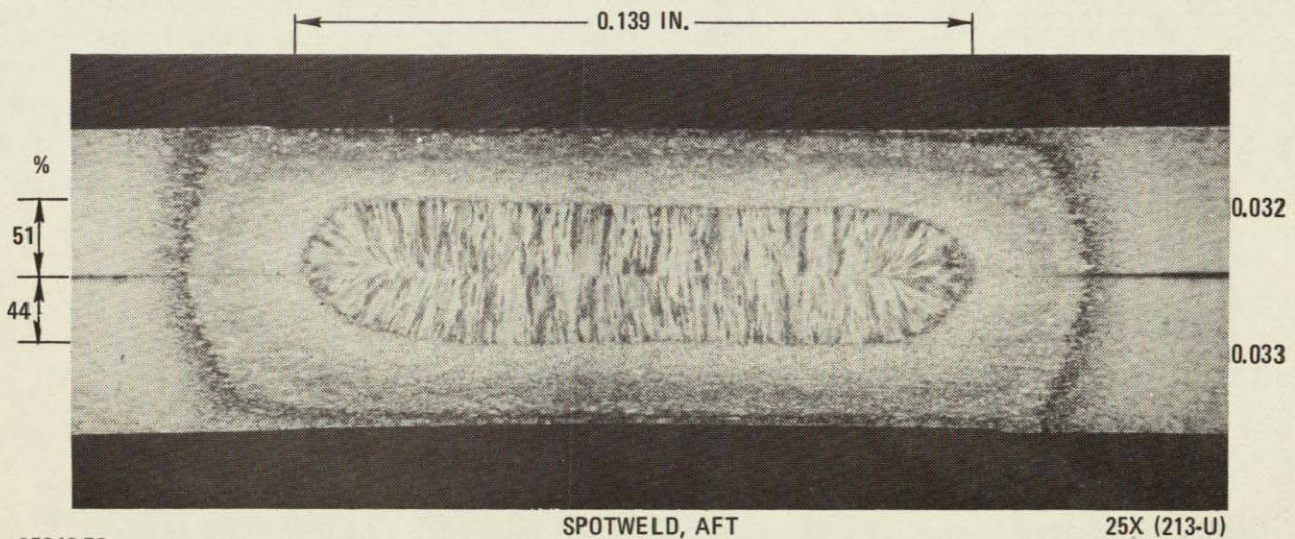
Figure 2-38. Defect-free Spot and Seamwelds

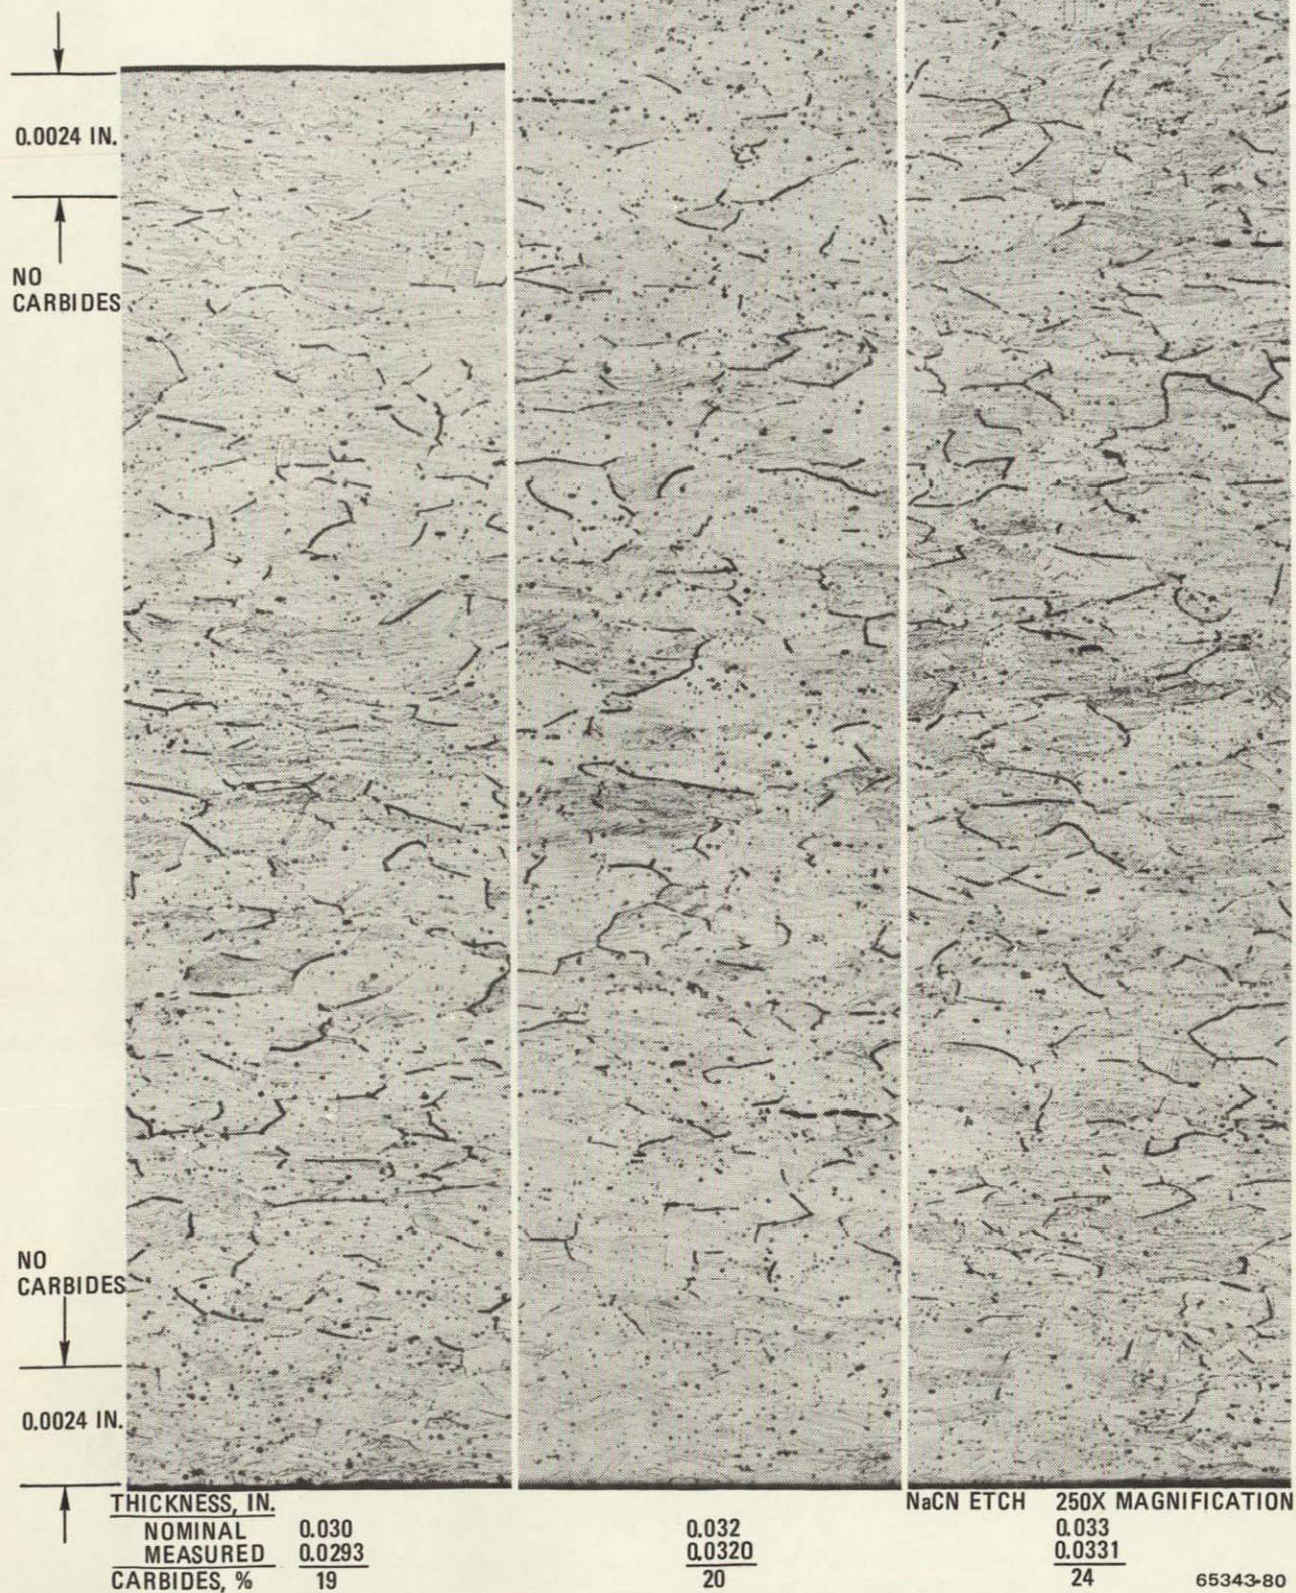
As may be seen in Figure 2-39, there was a region (layer) of material extending from each surface inward about 0.002 to 0.003 inch that contained no evidence of grain boundary carbides. This is logical, because these carbides form just after a coil comes out of the 2050°F annealing furnace in the 1600 to 800°F segment of the steam-quench cool-down cycle. The cooling rate will be slower in the center of the 0.072-inch-thick coil as compared to the surface. This metallographic evidence indicates, therefore, that the internal carbides formed during the cool-down after the final anneal cannot be a factor in the initial stages of surface corrosion attack.

Figure 2-39. Grain Boundary Carbide Distribution

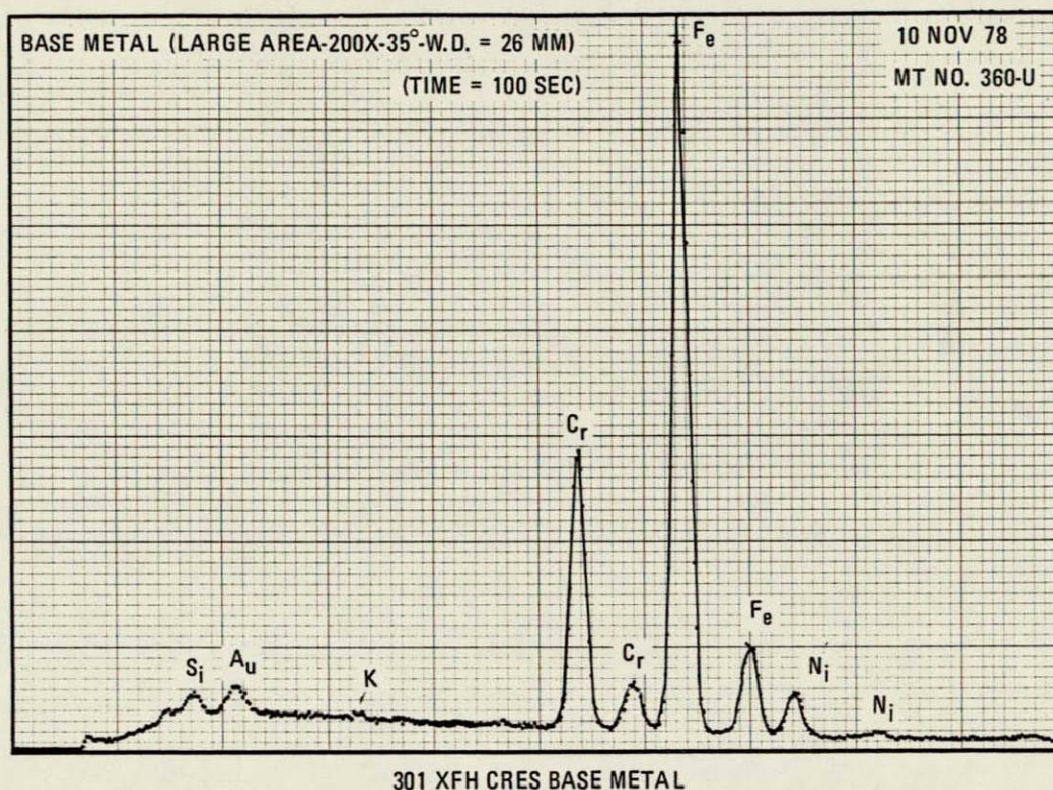
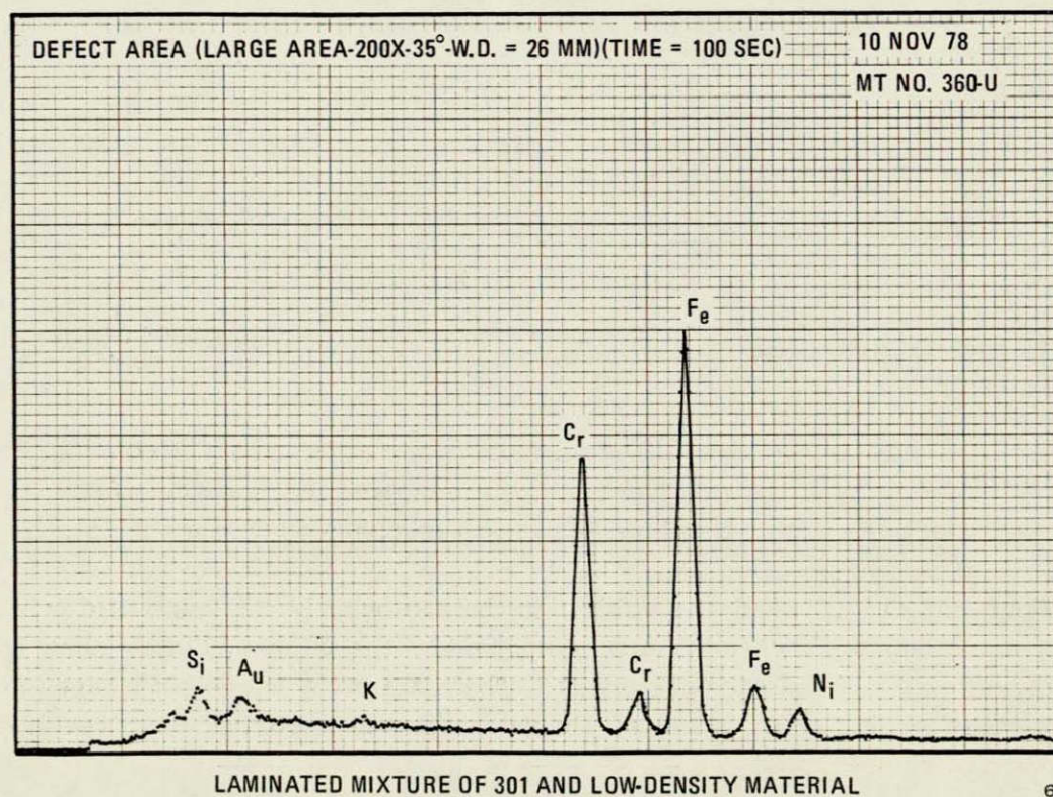
**2.3.5 ELEMENT ANALYSES, COMPARISON.** To obtain some information on the chemical nature of the laminated mixture of materials discovered in the low-density defect indications of Items 1 and 2 (Figures 2-6 and 2-9), semi-quantitative analyses for elements greater than atomic number 12 (Mg) were made in the defect area and, for comparison, on a similar sized area on the base metal (301 CRES) using the X-ray energy dispersive accessory on the scanning electron microscope. The results are presented in Figure 2-41. The white material (see Figure 2-8) in this laminated mixture was determined to be 301 CRES base metal.

Figure 2-41. Energy Dispersive X-ray Analysis Results

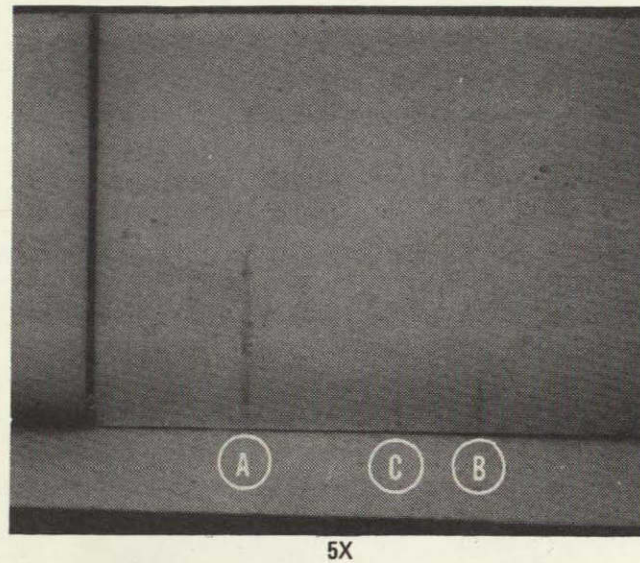
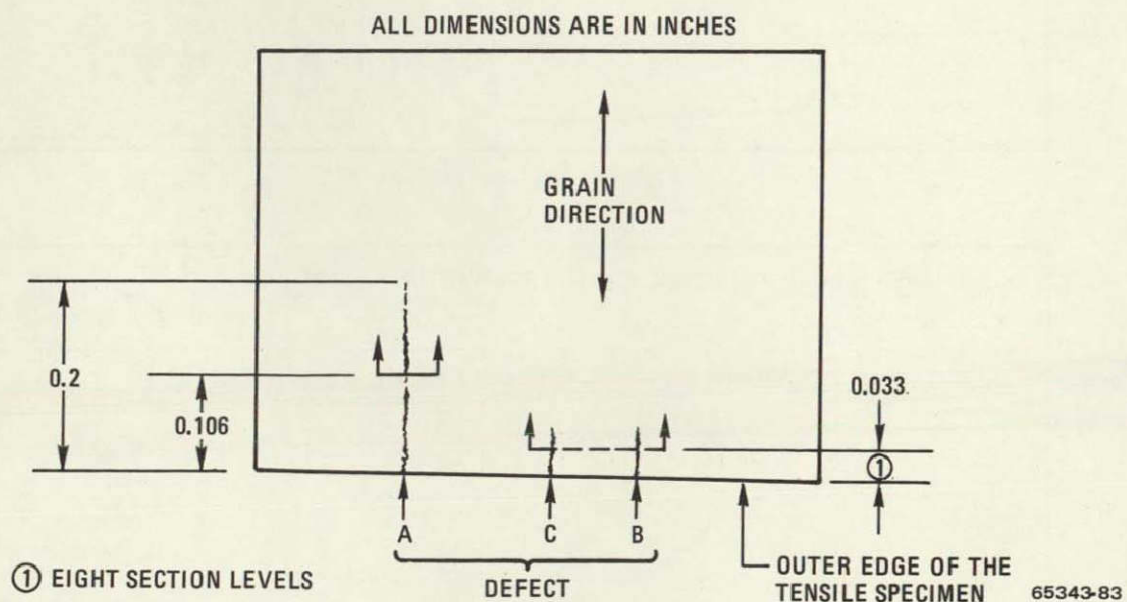
**2.3.7 EXPOSED DOGBONE TENSILE SPECIMEN, DEFECT IMAGES.** Radiographs of some of the corrosion-exposed tensile specimens had long, dark defect-type images extending in from the outer edge of the tensile specimen. These images ran parallel to the grain direction. The radiographic image appearance of three of these defects (labeled A, B, and C) is shown in Figure 2-42 for Pt. Loma specimen "Q". Defect A was first sectioned in the plan-view direction to about 0.003 inch beneath the surface (see Figure 2-43). The remaining material was then sectioned in the transverse

Figure 2-42. X-ray Appearance of Defect Indications A, B, and C Extending Inward from the Edge of a Tensile Specimen, and the Location of the Metallographic Sections Shown in Figures 2-43 through 2-45

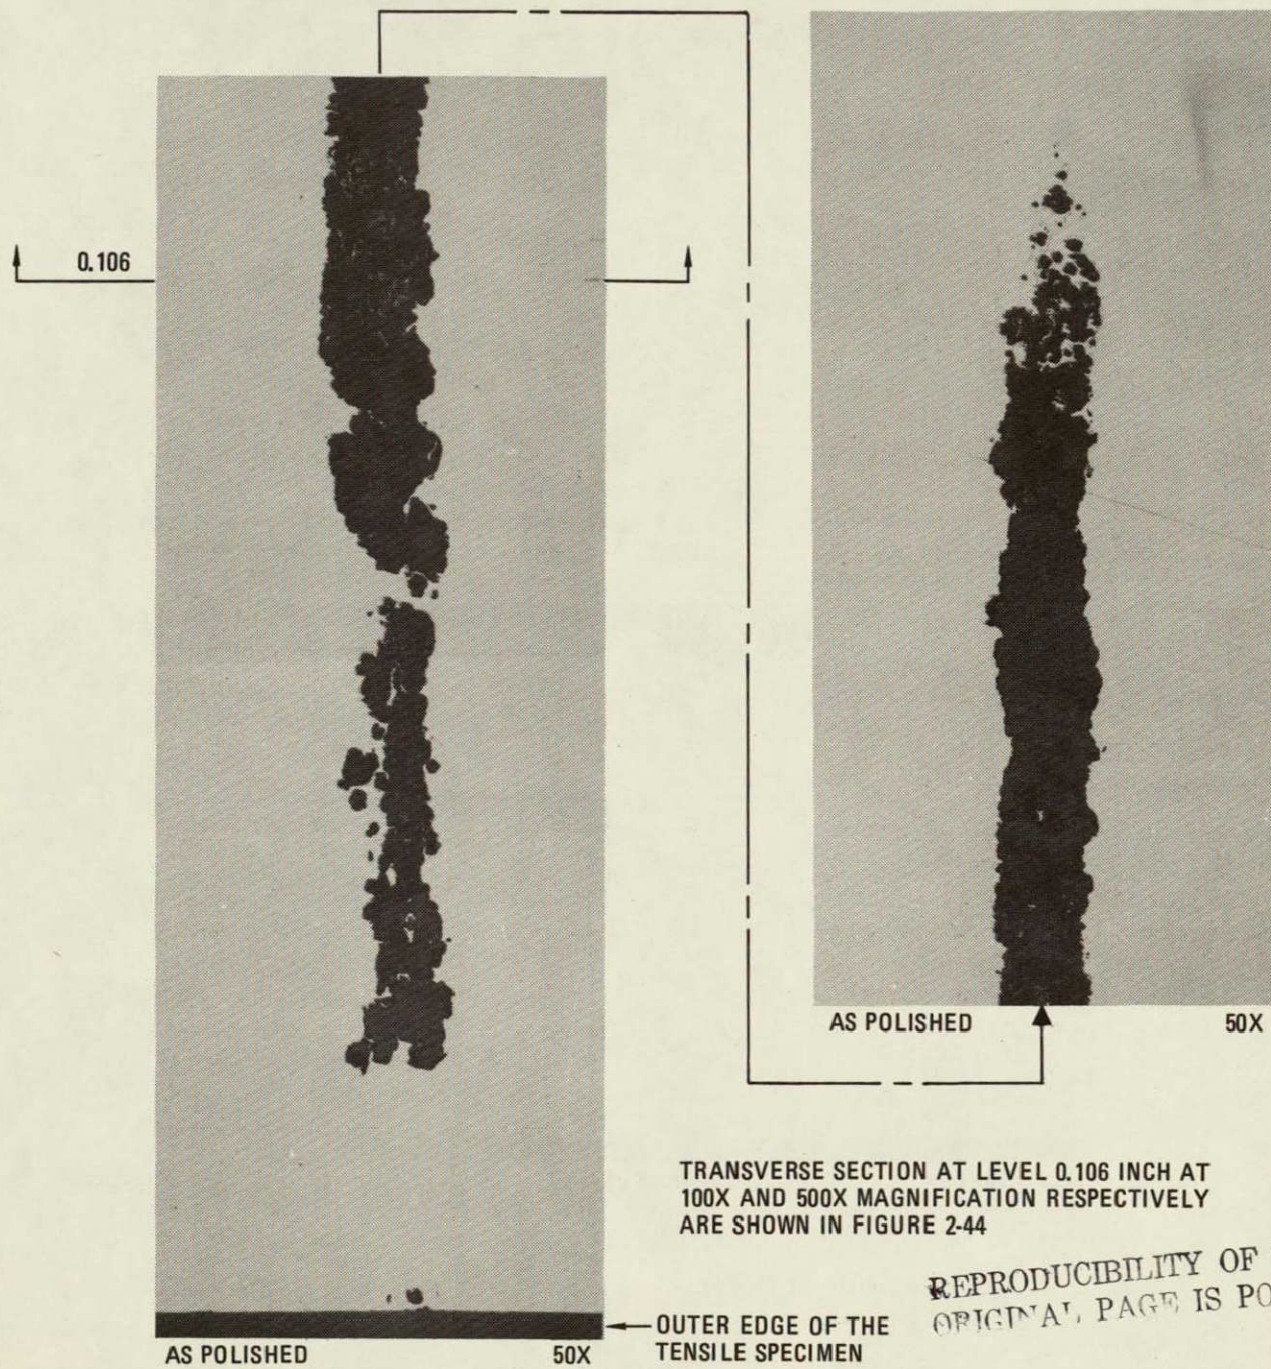
The sectioning revealed that the defect images were caused by long, corrosion pits or tunnels running parallel to the grain direction.

Figure 2-43. Appearance of a Plan View Section of Defect A About 0.003 inch Beneath the Surface

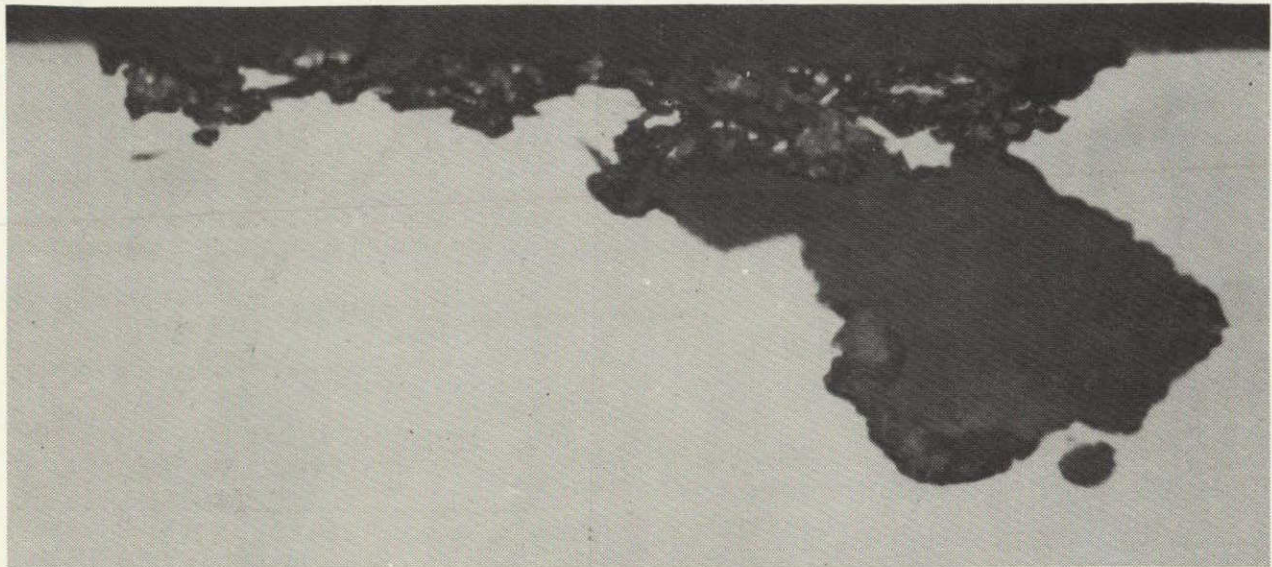
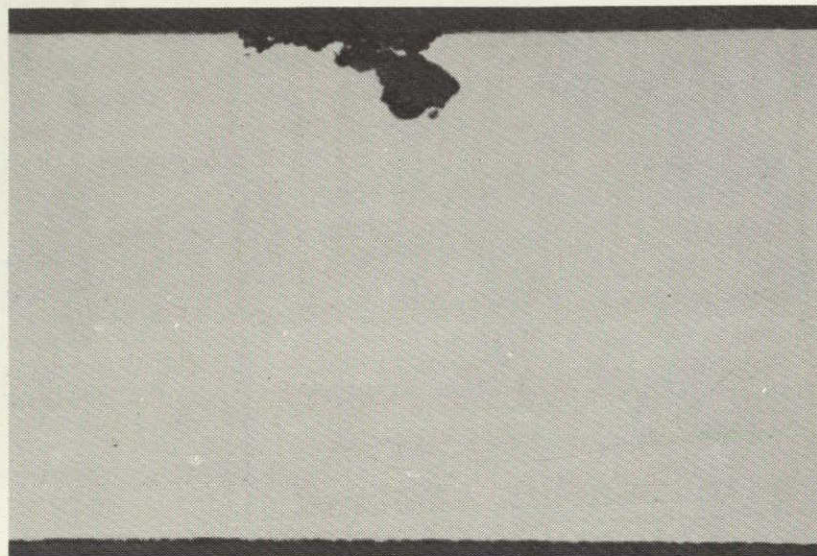
Figure 2-44. Appearance of Defect A at Transverse Section Level 0.106  
(see Figures 2-42 and 2-43)

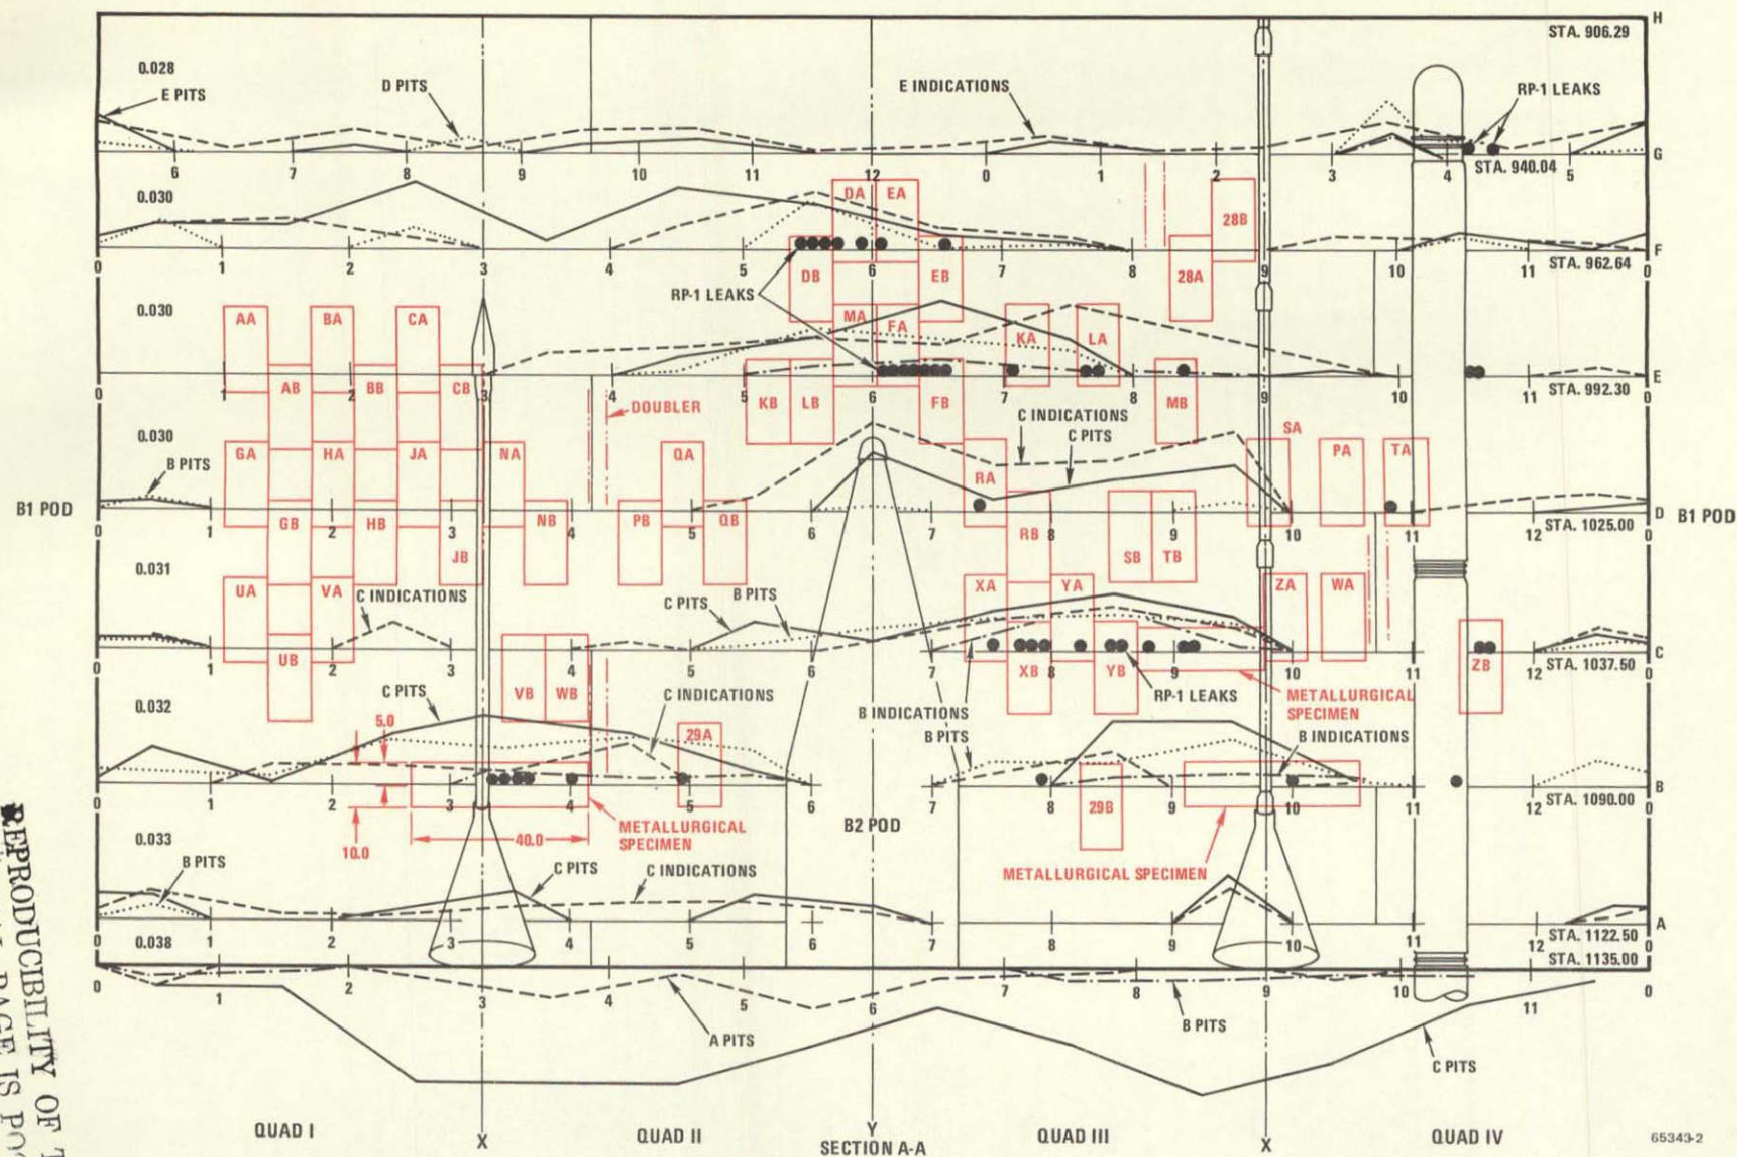
After the Atlas 5013 tank was returned to San Diego and stripped of non-tank items, the corroded areas were x-rayed. The analysis of these radiographs is contained in Reference 9. These results are summarized in Figure 4-1, which shows the location and degree of severity of the corrosion. From this data and a review of the x-rays, locations were chosen from which to cut out specimens for the mechanical property and corrosion tests. Corroded and clean specimens were taken from the areas shown in red in Figure 4-1. The details of the specimen configuration are shown in Figures 5-1 and 5-2. The assignment of specimens to various types of tests and test conditions as well as the type of corrosion represented by the specimen is shown in Figures 4-2 and 4-3. An x-ray positive print of typical defects is shown in Figure 4-4 and corresponds to the metallurgical section shown in Figure 2-36.

Figure 4-1. Circumferential Corrosion Distribution and Specimen Locations

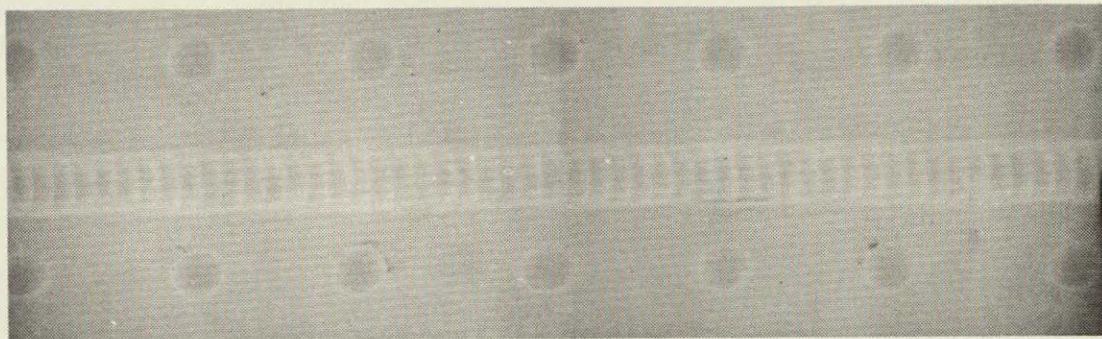
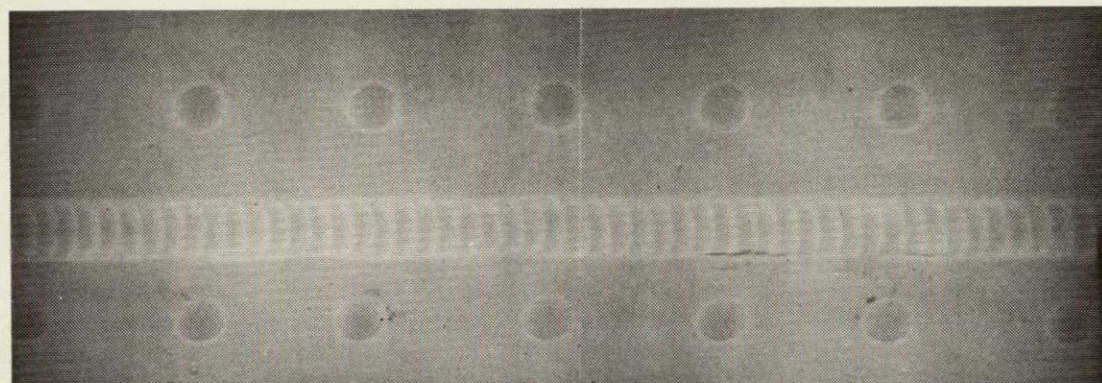
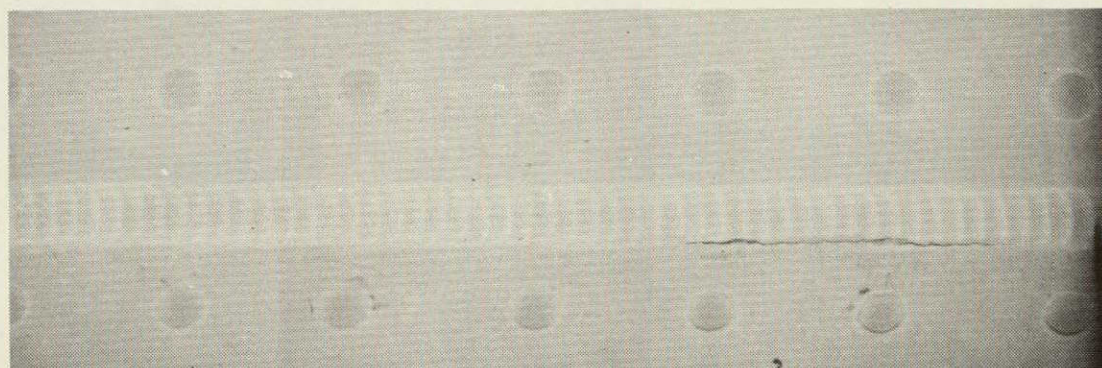
X-rays were taken every 100 cycles of the fatigue test on specimen "Y" to follow the growth of a typical circumferential defect. This defect is a crack that occurs in heat affected zone at the edge of the seam weld. Metallurgical cross sections of this type of defect are shown in Section 2. Figure 4-7 shows the progression from 100, 500, and 646 cycles for specimen YA. The specimen failed at the YB joint at 646 cycles. The progression of YB is shown in Figure 4-8 at 100 and 500 cycles.

Figure 4-7. Crack Growth as a Function of Fatigue Cycling (Joint YA,  
0 - 67 ksi, Room Temperature)

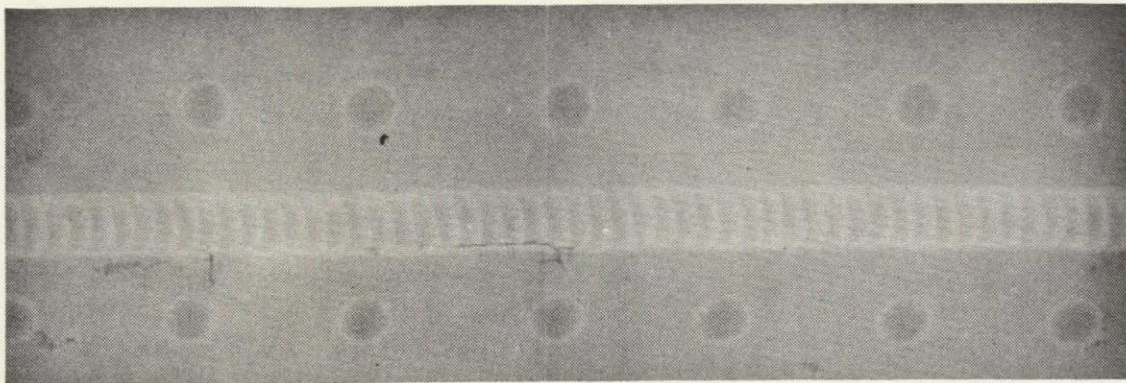
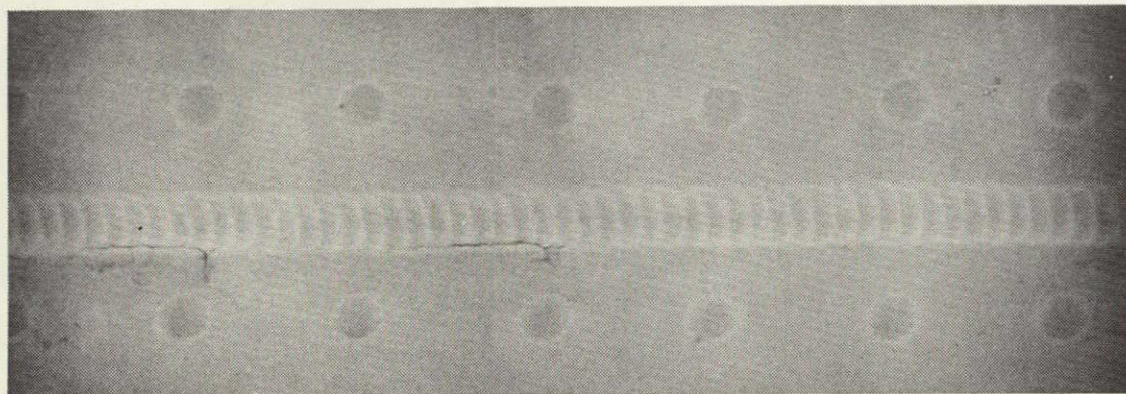
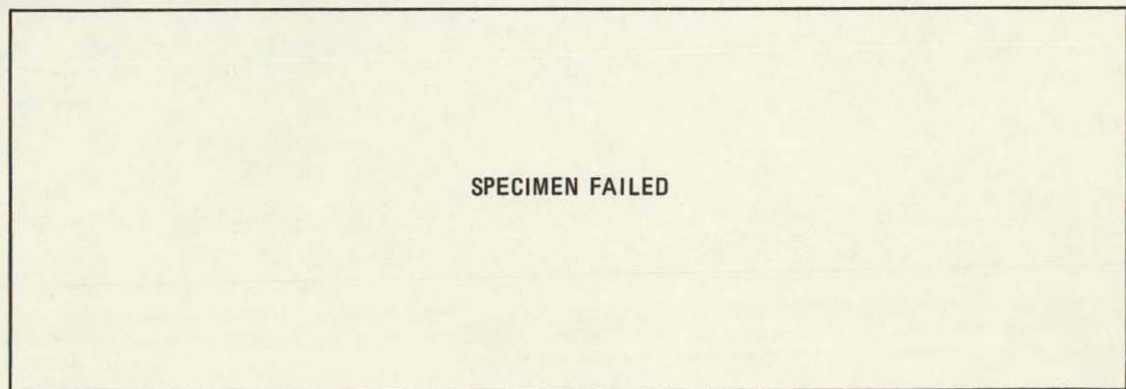
Figure 4-8. Crack Growth as a Function of Fatigue Cycling (Joint YB,  
0 - 67 ksi, Room Temperature)
